MOTORCYCLE SERVICE NEWS

NUMBER 300

DATE 10/13/72

TX750 HEADSTOCK GUSSET, Enlargement of wiring hole

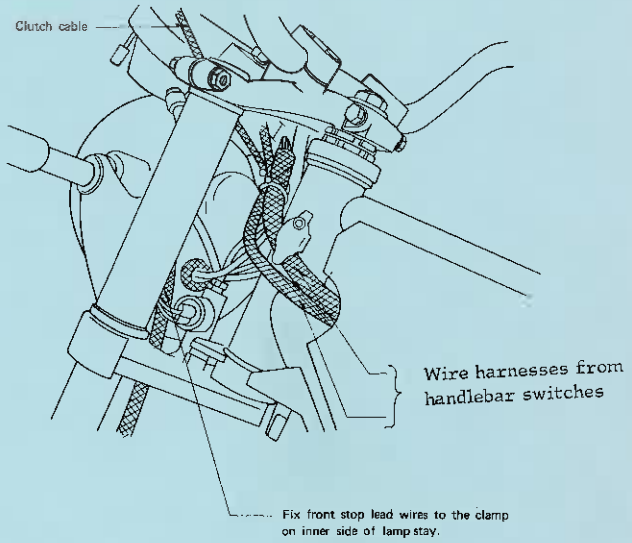
Right Side

On some TX750 machines, the wiring hole on the right-hand headstock gusset is not large enough to pass the main switch harness connector. This hole may be enlarged by inserting the chisel end of a 24" (+) crowbar between the gusset and head pipe, and carefully and slowly bending out the gusset.

Be careful when using the crowbar that wiring inside frame near headstock is not damaged. See drawings below for correct routing of electrical wiring and control cables in headstock area.
