MOTORCYCLE SERVICE NEWS

NUMBER 309

YAMAHA INTERNATIONAL CORPORATION
BUENA PARK, CALIFORNIA 90620
DATE 6/7/73

TX750 — OIL LEAK AT CAMSHAFT CARRIER BASE

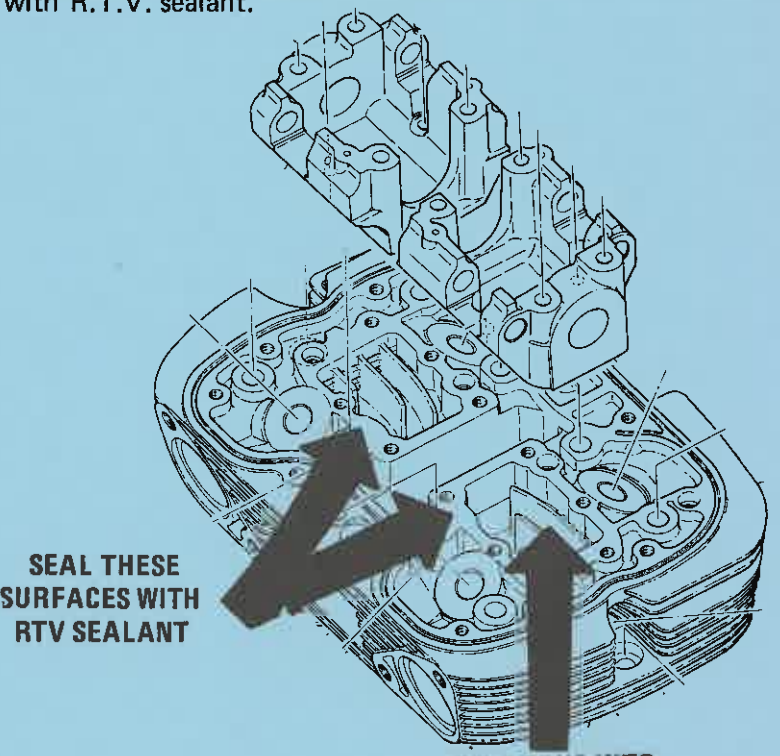
Oil around the head gasket joint on TX750's may be caused by leakage between the cam carrier base and head. (See illustration below.) Oil will leak under carrier into air passages between cylinders. Check carefully around the spark plug area and front and rear of head to determine if cam carrier or head gasket leaks. If cam carrier leaks, remove and seal with R.T.V. sealant.
