MOTORCYCLE SERVICE NEWS

NUMBER 322
PAGE 1 of 1

TX750 — CAM CHAIN SPROCKET ALIGNMENT

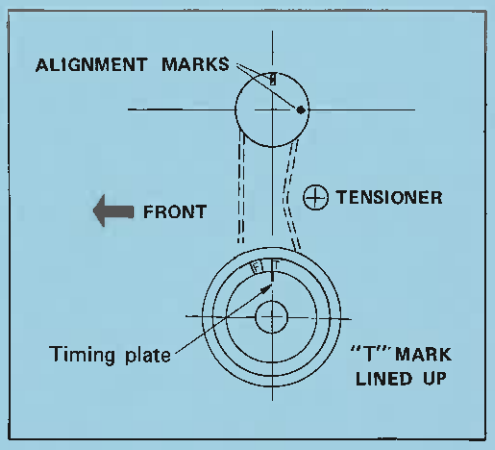
The illustration on Page 22, TX750 Service Manual (1st Edition, LIT-11613-41-00) and on Page 24, (2nd Edition, LIT-11613-41-73) are both incorrect. The cam sprocket punchmark should be 90° clockwise of the groove. See correct illustration below and correct service manual(s) accordingly.
