MOTORCYCLE SERVICE NEWS

NUMBER 346

TX750 CRANKSHAFT AND ROD JOURNALS, Size Code Location Change

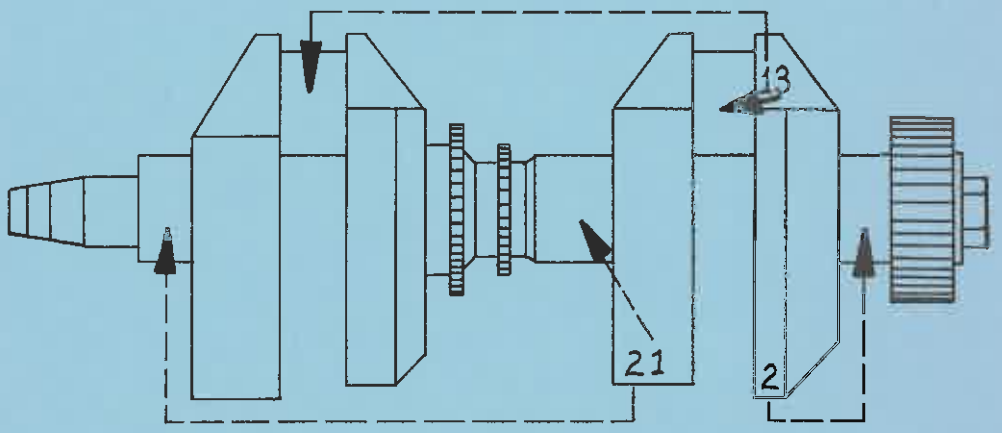
Main Bearing and Rod Bearing journal sizes are identified by code numbers stamped on the webs. The locations of these code numbers have been changed. The illustration below shows the new number location and the journal applicable to that location.
