TX500A/TX650A/TX750

M4-005

TECHNICAL BULLETIN

REAR BRAKE CAMSHAFT, Addition of washer

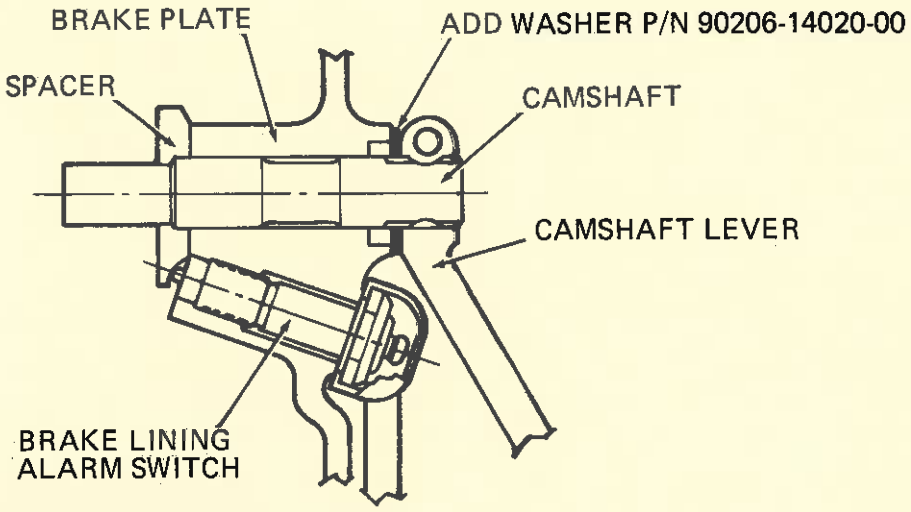
Excessive lateral movement of rear brake camshaft may cause premature operation of the brake lining alarm switch and indicator lamp.

To prevent this a wave washer should be added between the brake shoe plate and the camshaft lever. See drawing below.
