MOTORCYCLE PARTS NEWS

NUMBER 397

DATE 10-23-73

TX750 — CRANKSHAFT, Design Change

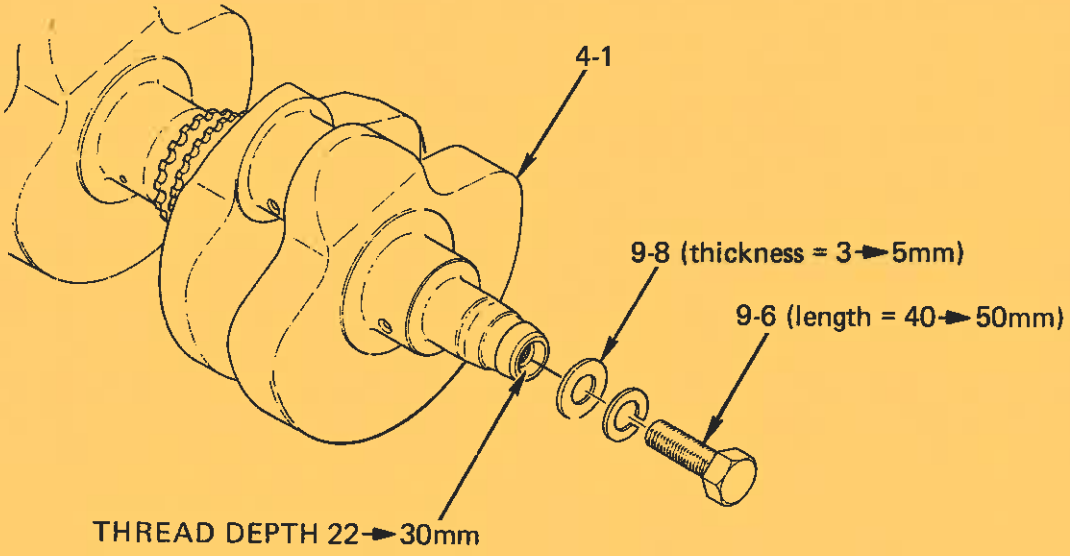
The AC generator rotor securing bolt and washer have been changed for greater strength. A corresponding change has been made to the crankshaft. See details of change in illustration below. Correct your Parts List per the Parts Ordering information.

INTERCHANGEABILITY: Okay as set.

SALE OF PARTS: Crankshaft — When old type out of stock, only new will be sold.
Bolt/Washer — Both old and new type will continue to be sold.
